Development of Test Methods for, and the Evaluation of, Miles Transducers

John D. Ramboz

Engineering Mechanics Section, Mechanics Division
Institute for Basic Standards
National Bureau of Standards
Washington, D. C. 20234

June 1976

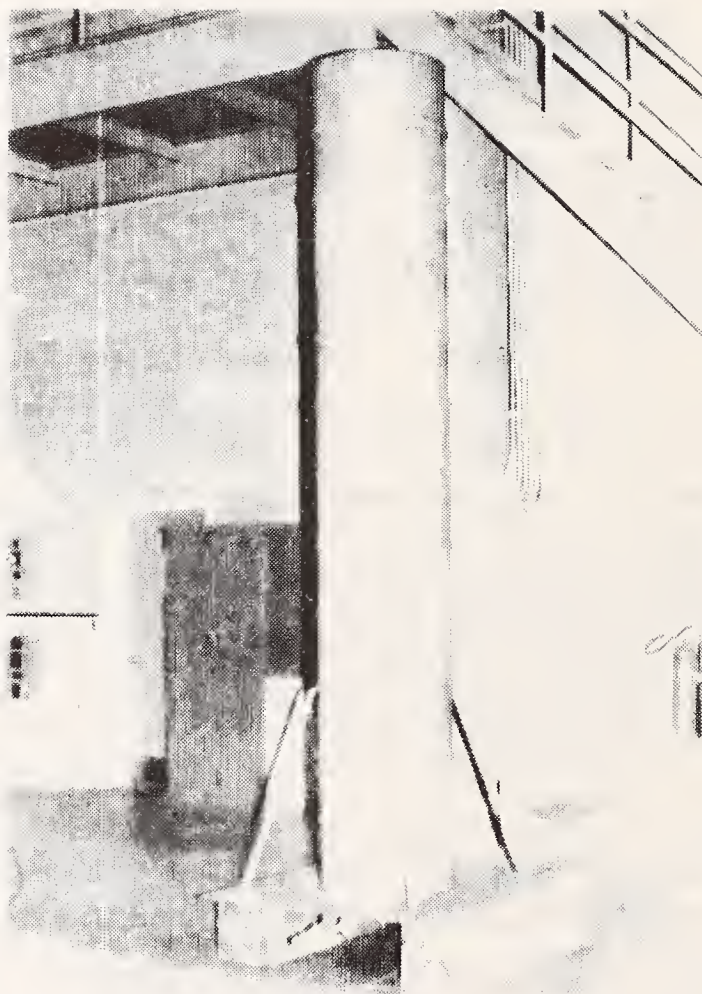
Figure 1. Steel tank used for long-term resistance to corrosive moisture.

A wooden rack was made to secure and support each of the fourteen transducers (7 round and 7 flat) vertically in the tank. The lower ends of the transducers were loosely secured 46 cm (18 in) above the bottom of the tank. The upper portion of each transducer was tightly secured about 15 cm (6 in) below the top level of the tank. This arrangement allowed the transducers to change their lengths freely as they were heated and cooled, without placing unnecessary strain on them, while confining them horizontally at the ends. A steel heat exchanger was attached to each of the vertical rack supports to provide a heat source during the drying/bake cycle. It had an overall folded length of approximately 14.3 m (47 ft) and provided ballast to the wooden rack to keep it from floating. The effective area of this heat exchanger was about 1.5 m² (16.2 ft²). Low pressure steam was passed through this exchanger and bled to the atmosphere during the drying/bake cycle.

The tank was filled about 80 percent (155 gallons) with water and salt added to make the required 5 percent (by weight) solution. Live steam was then released at the bottom of the tank and allowed to pass directly into the solution. This process added water by steam condensation. By the time the solution boiled, the liquid was at its nominal level, about 43 cm (17 in) below the top of the tank. The total volume of solution was then about 730 liters (192 gallons). Temperature was measured and monitored by a thermocouple located at about one-third the height of the tank. Approximately 40 minutes were required for the temperature to reach boiling. The solution was maintained at boiling for six hours, after which the tank was drained. Heat

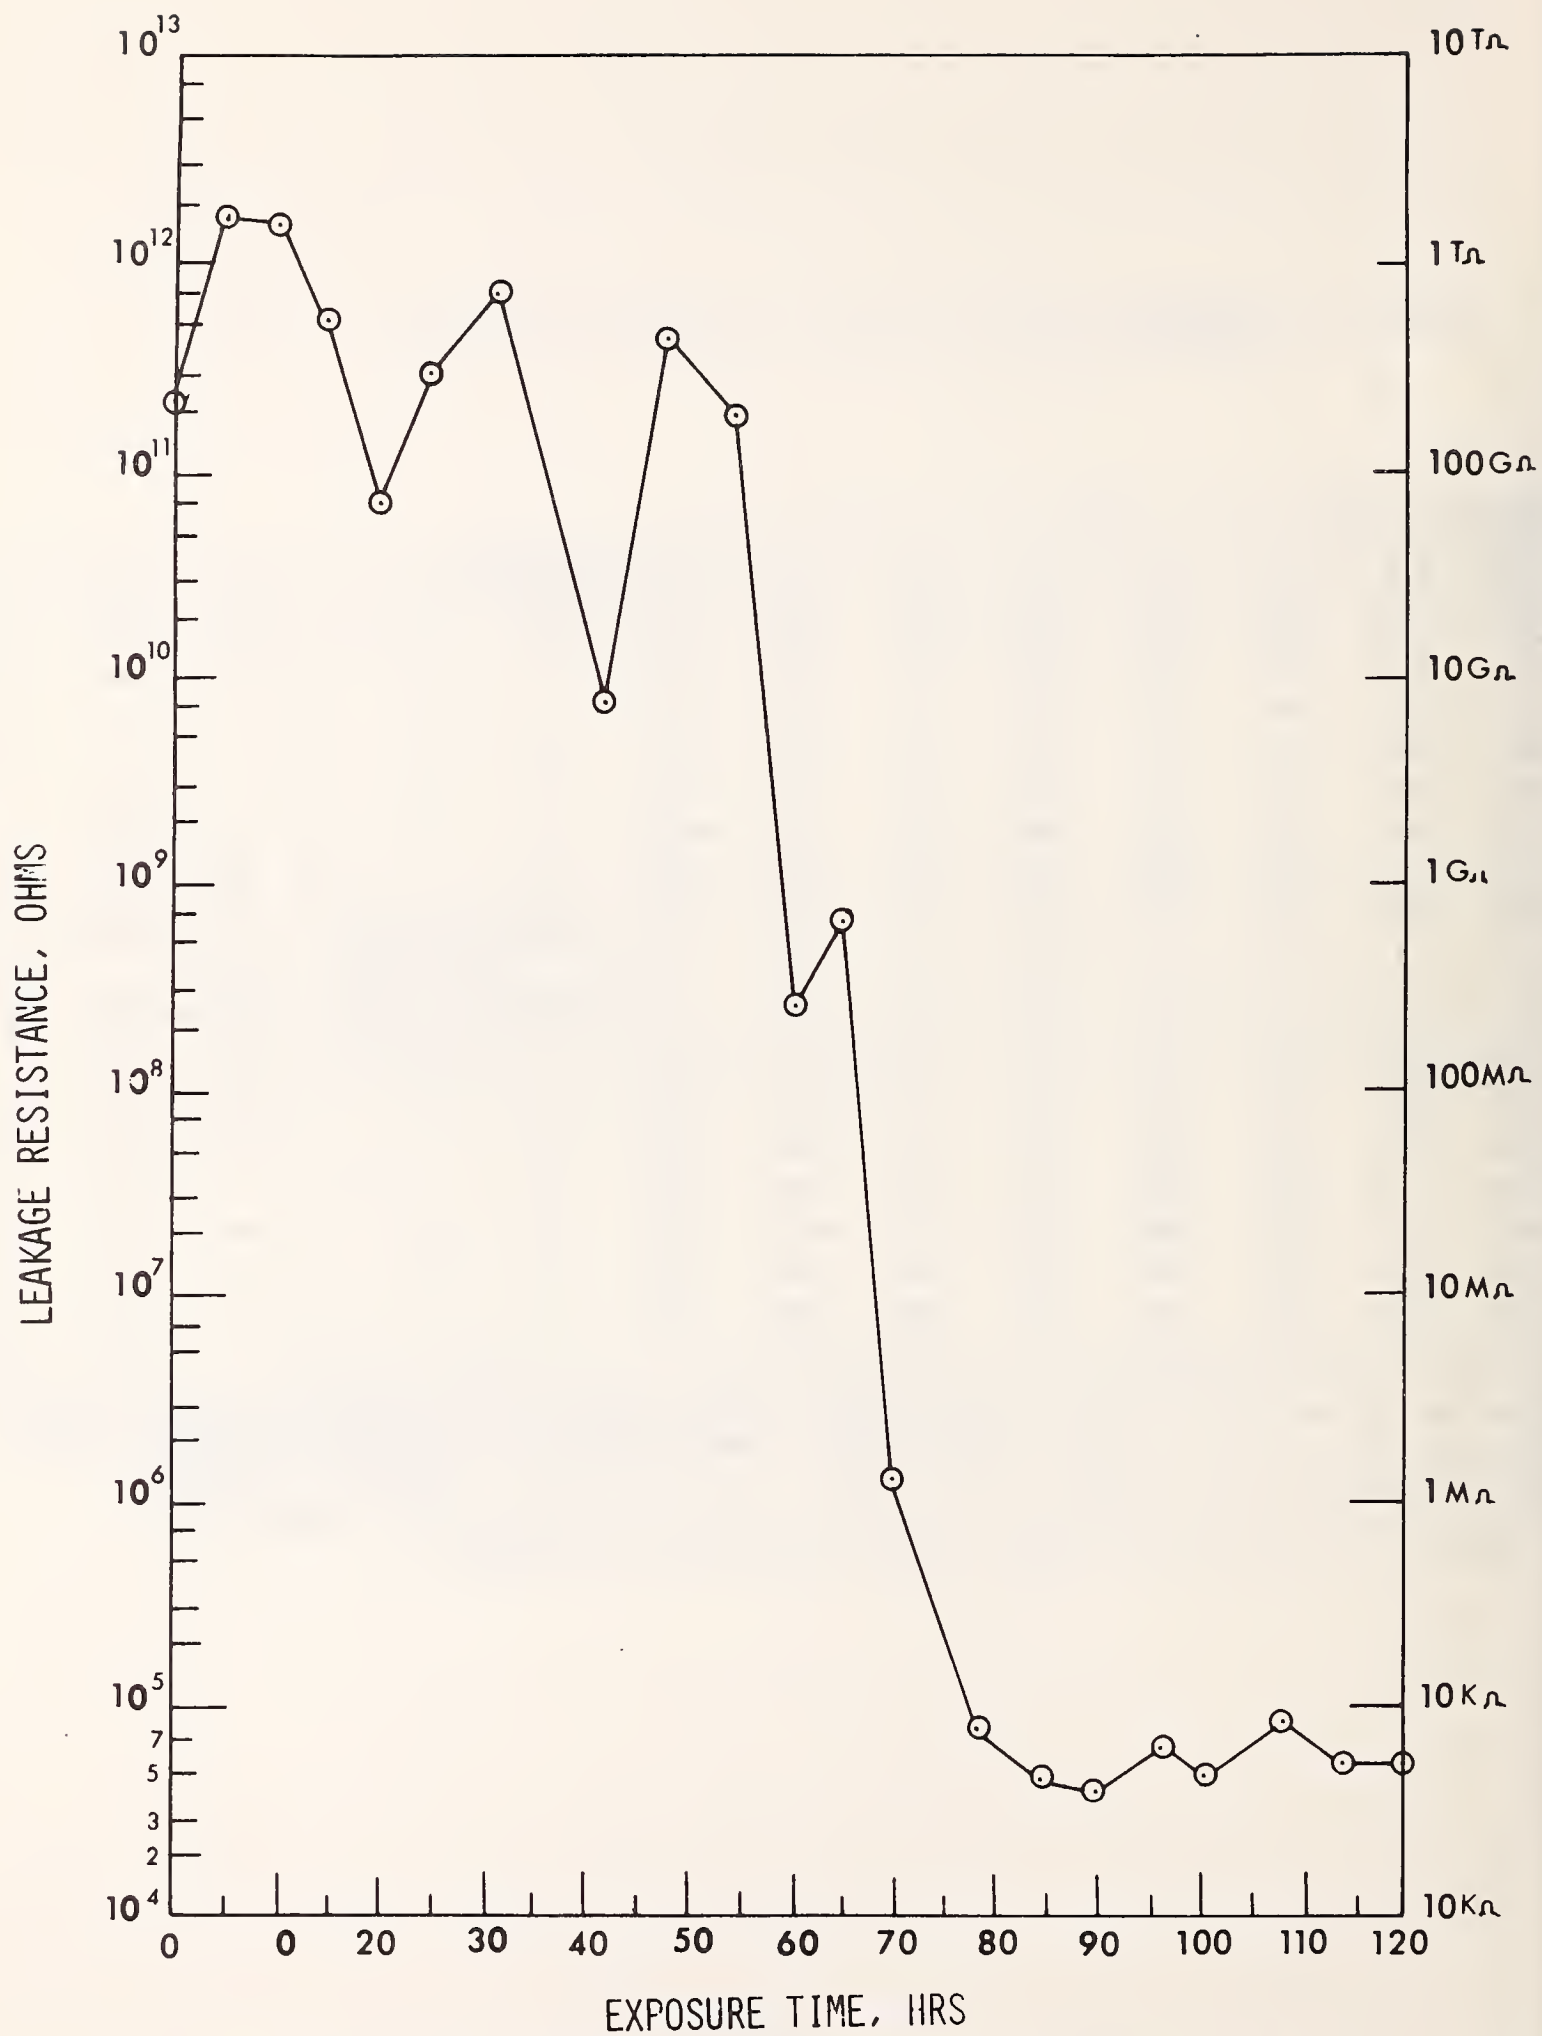
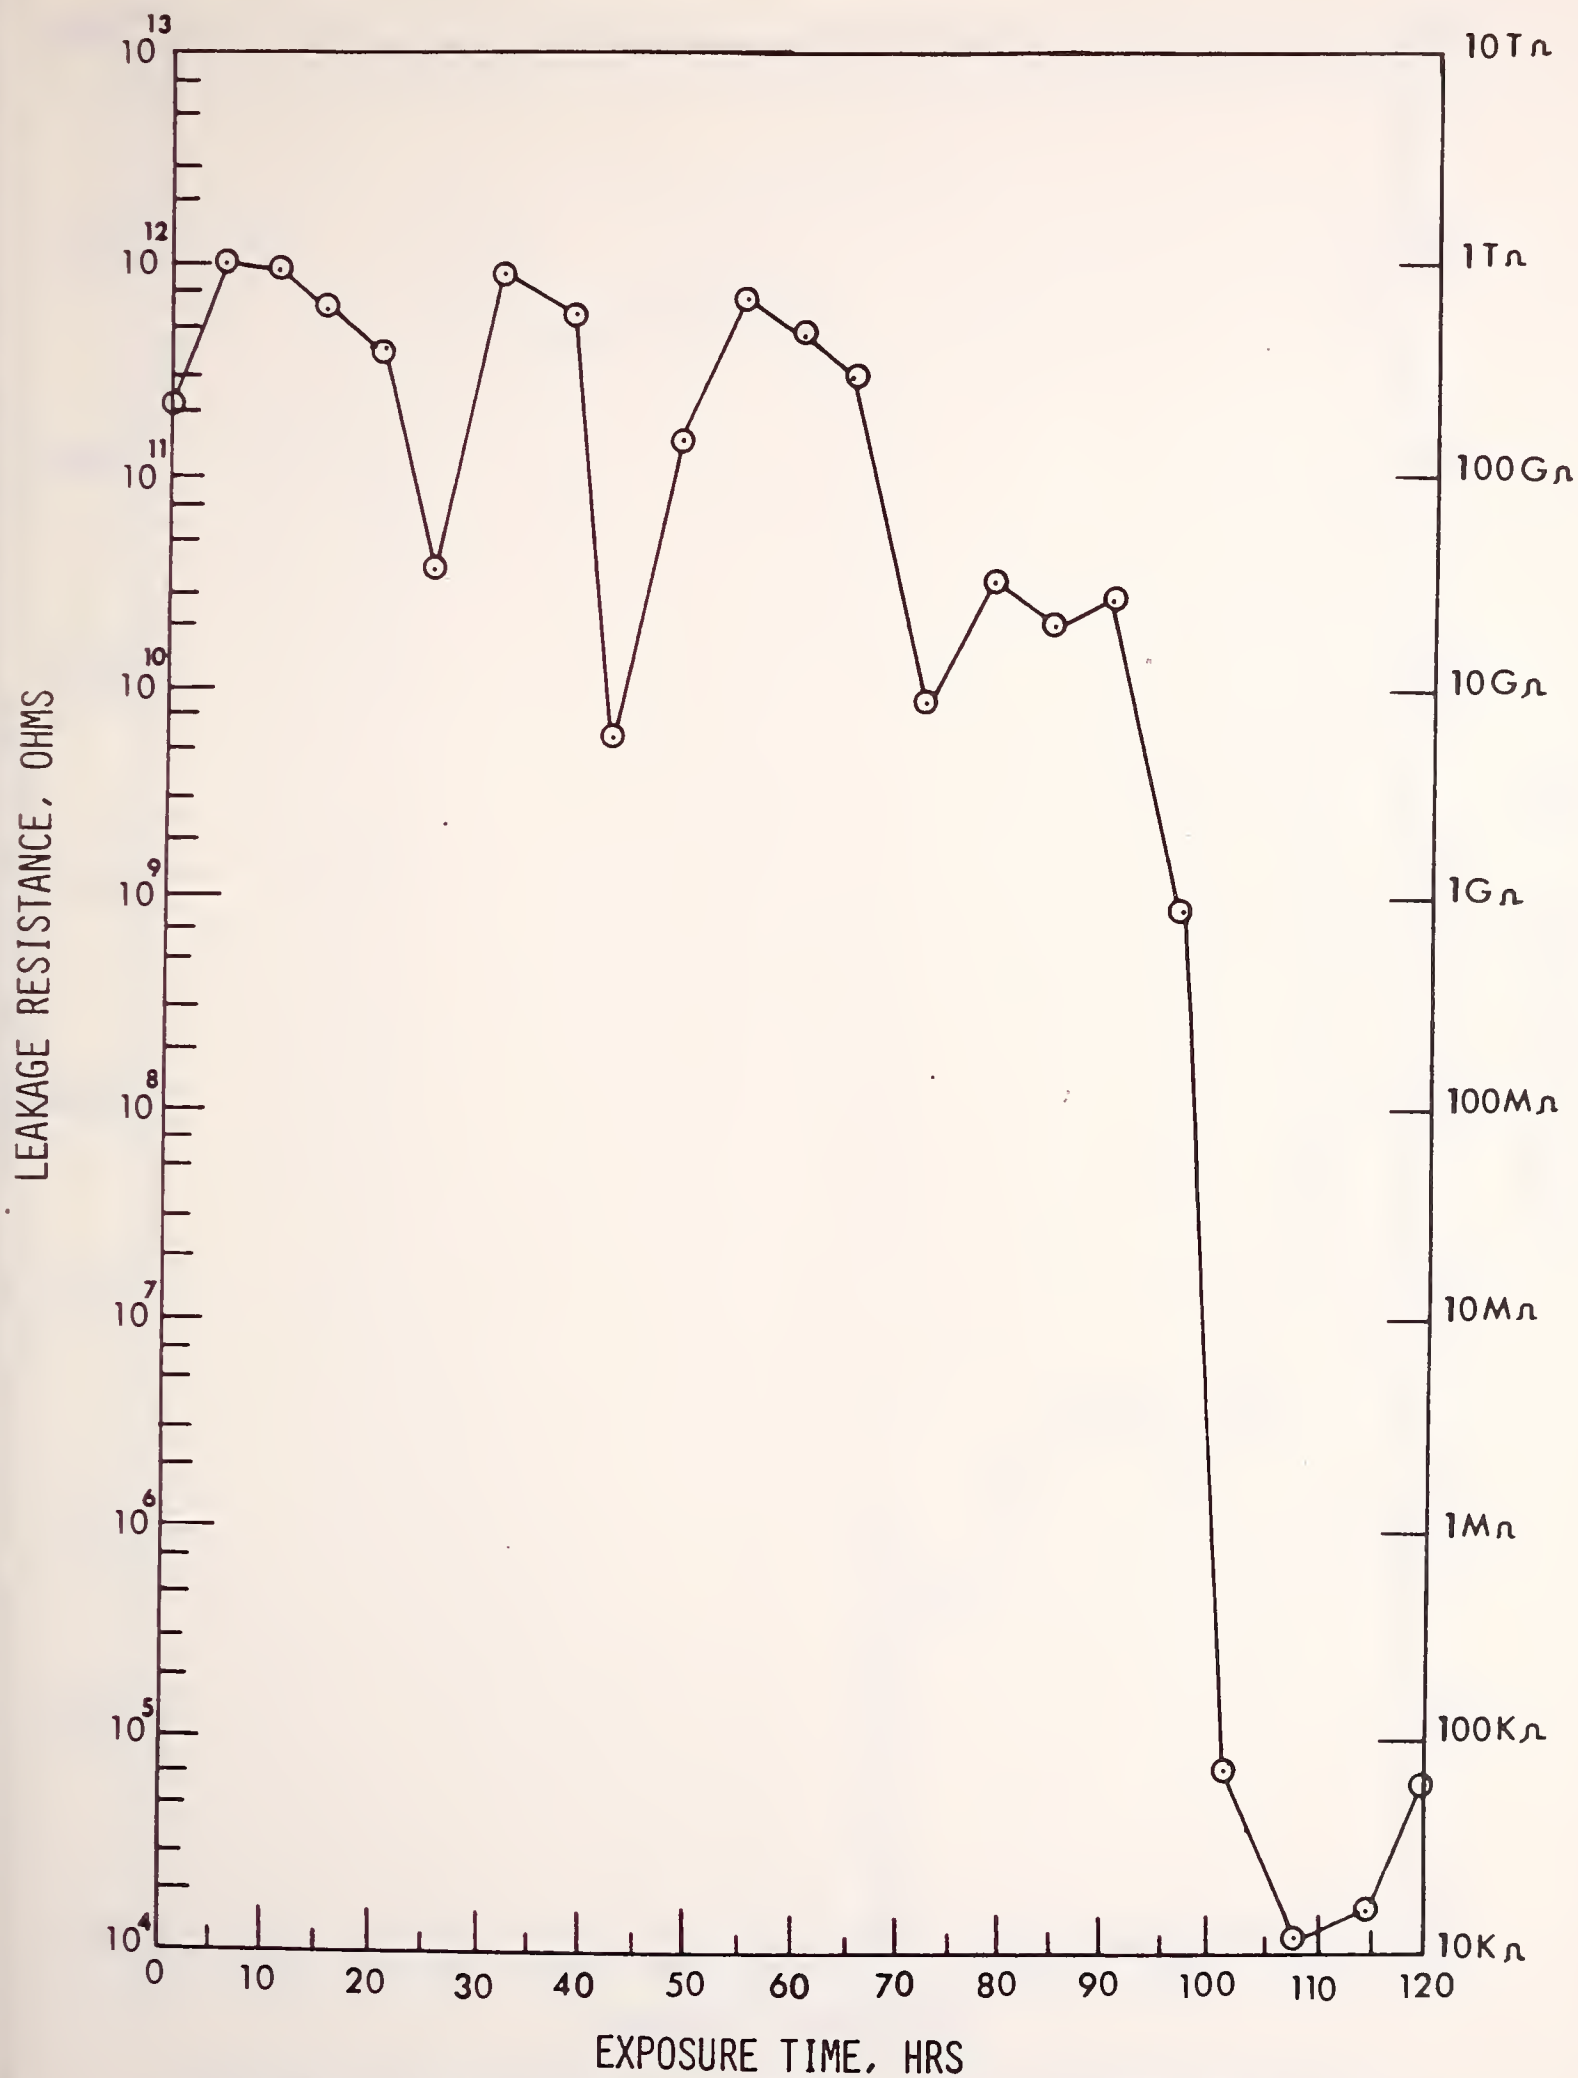
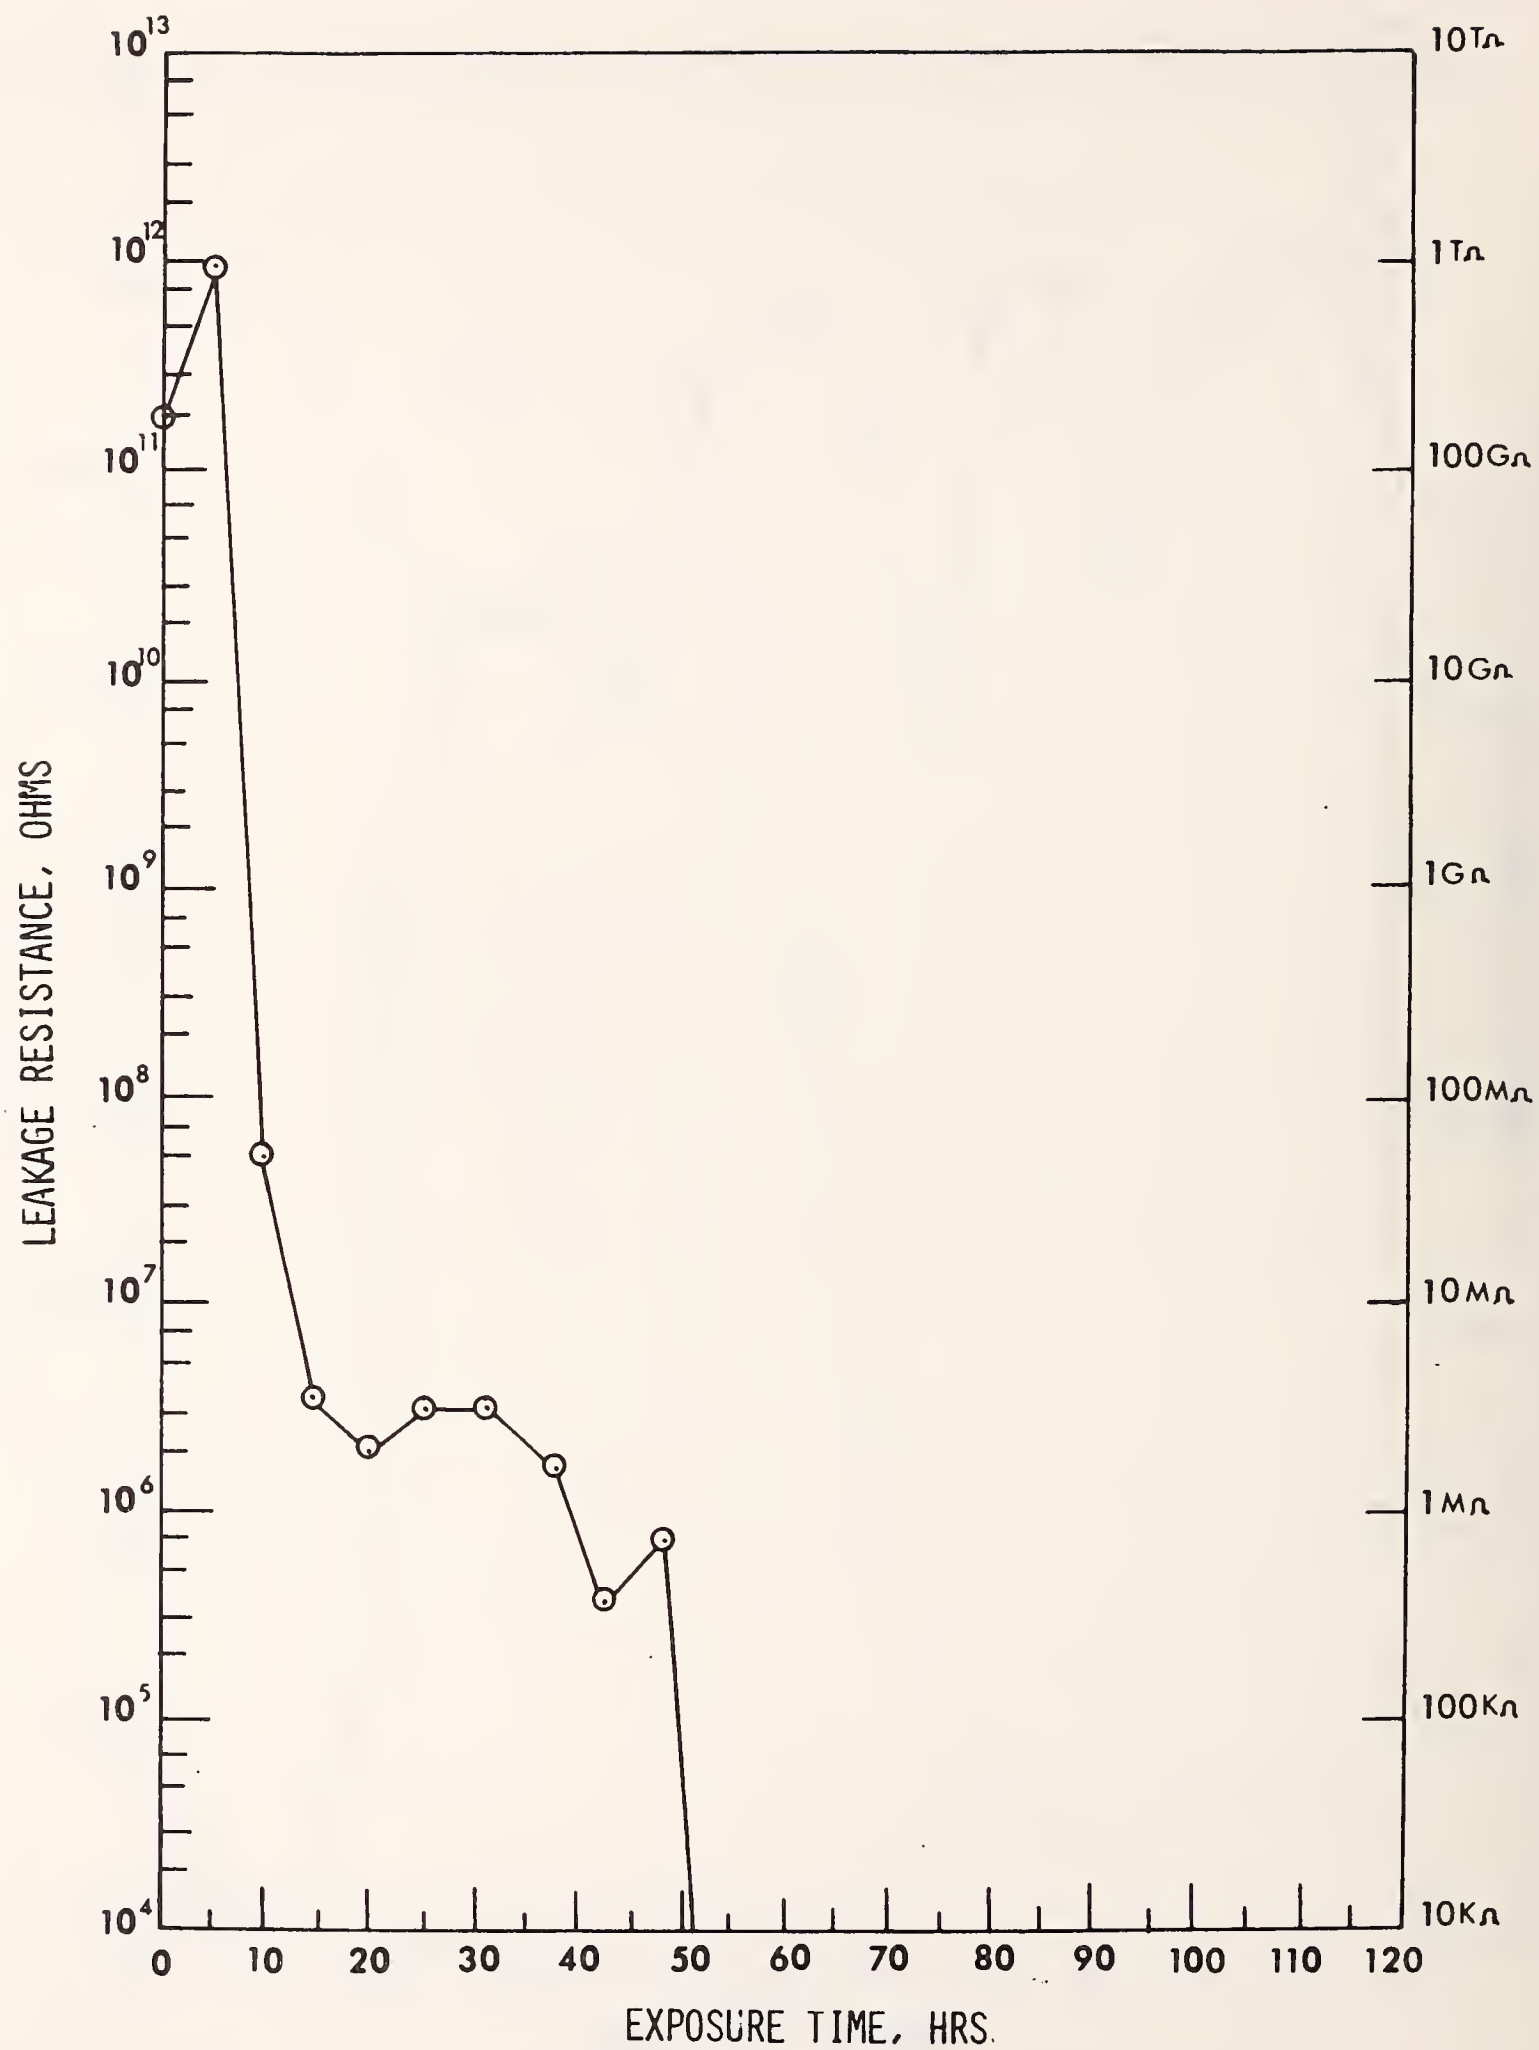
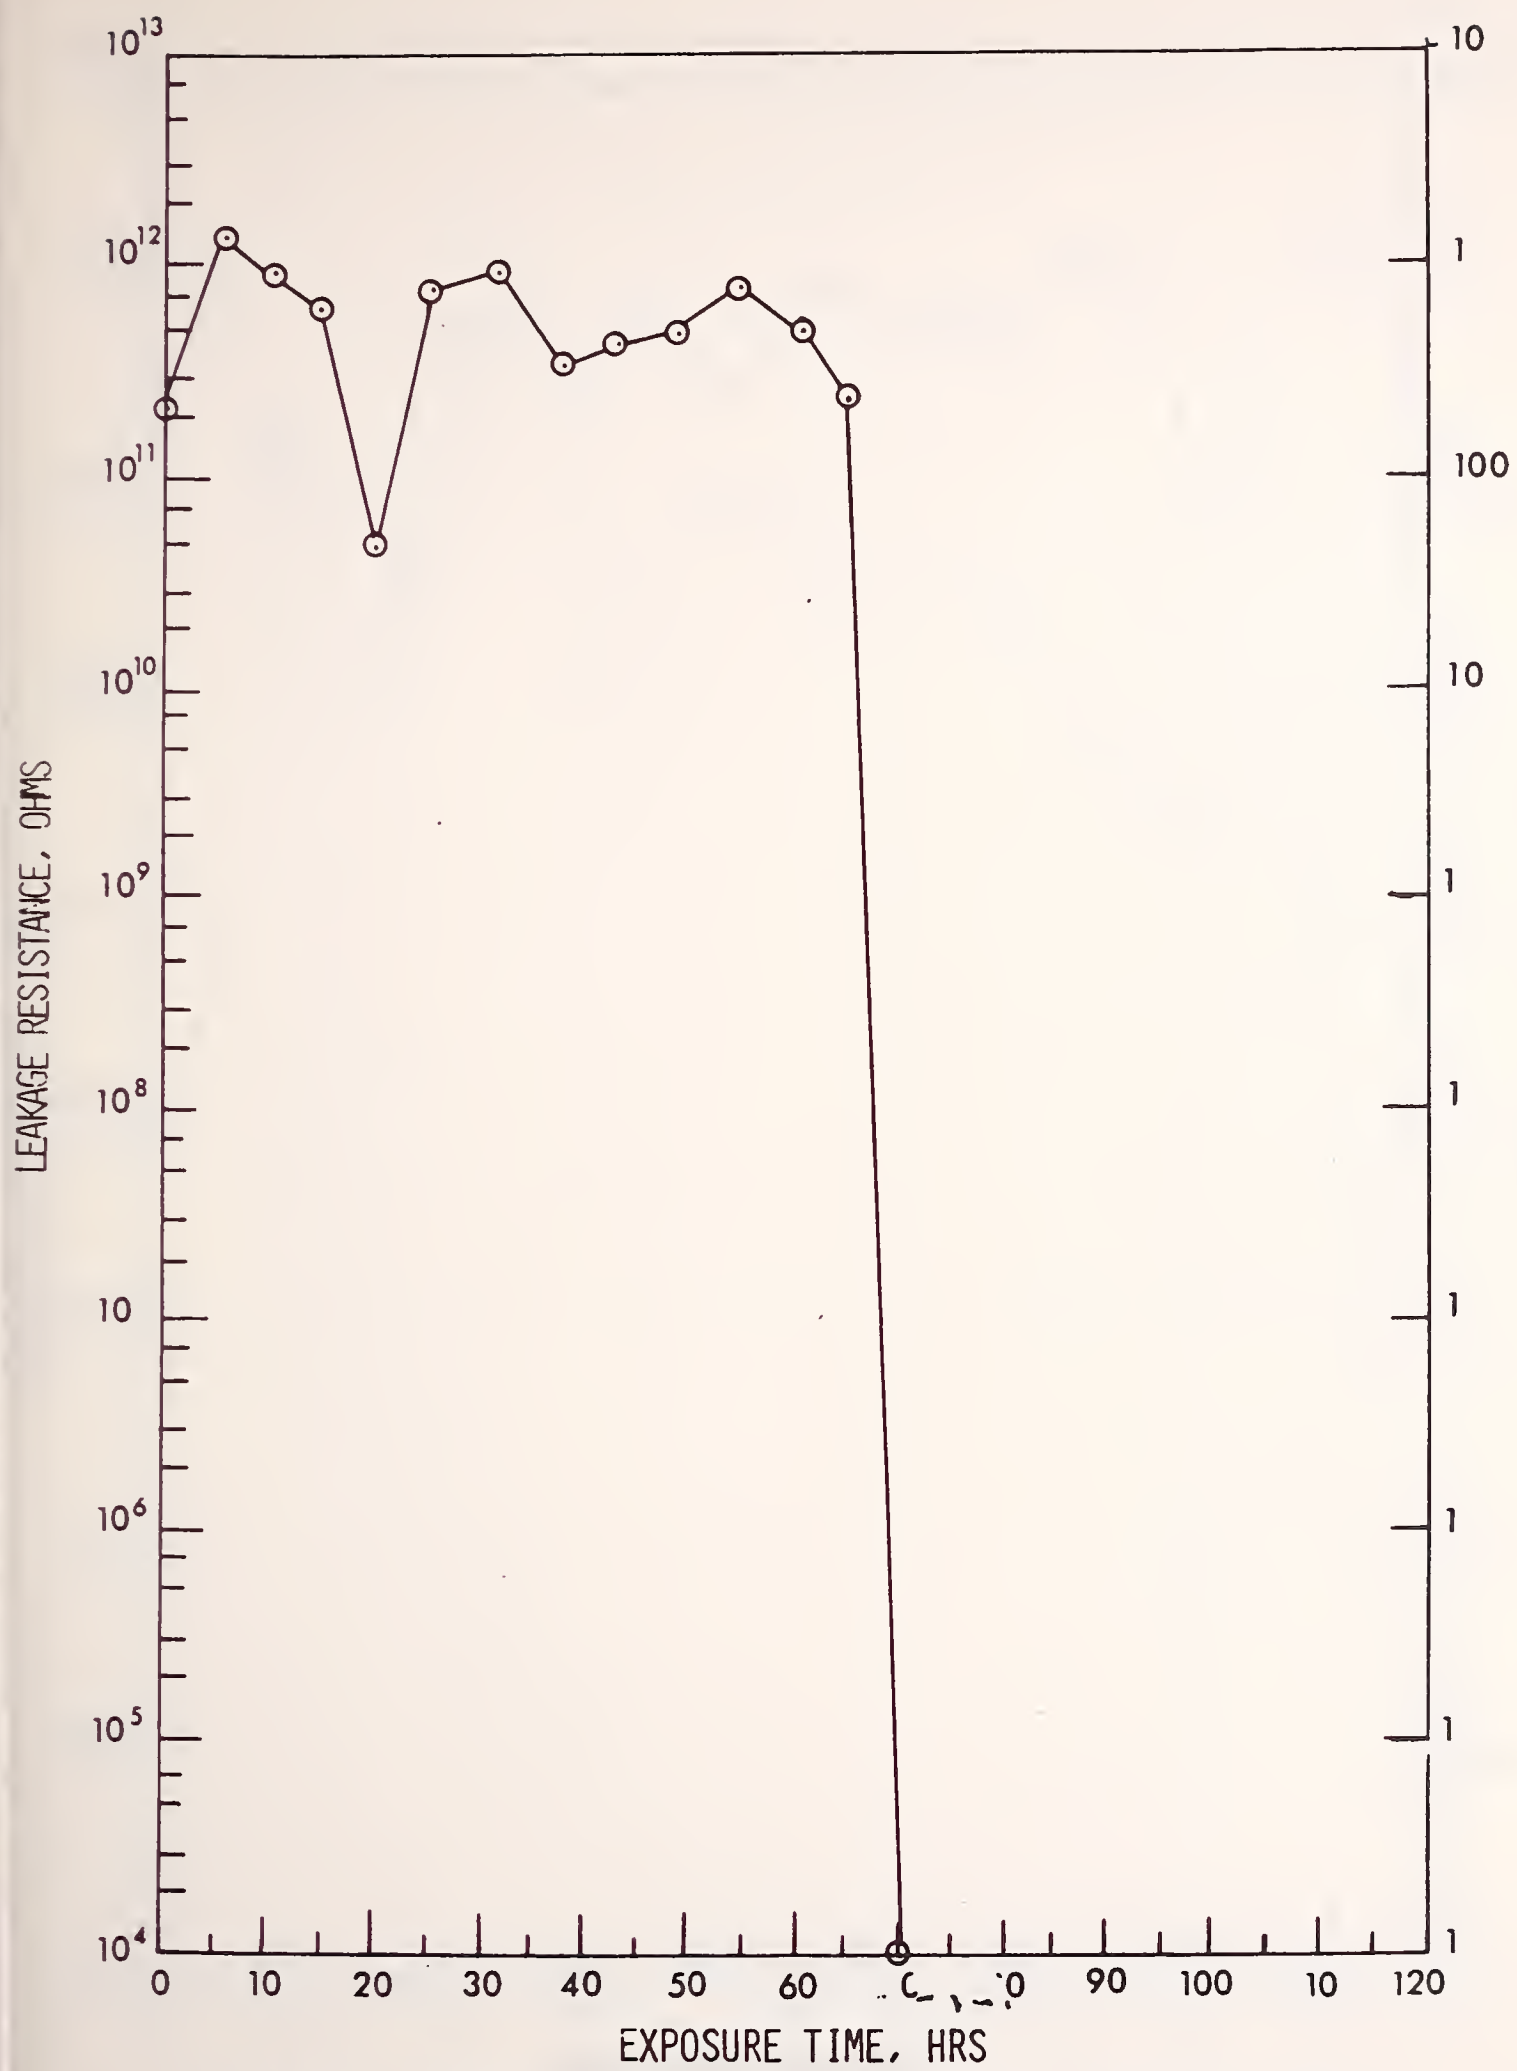
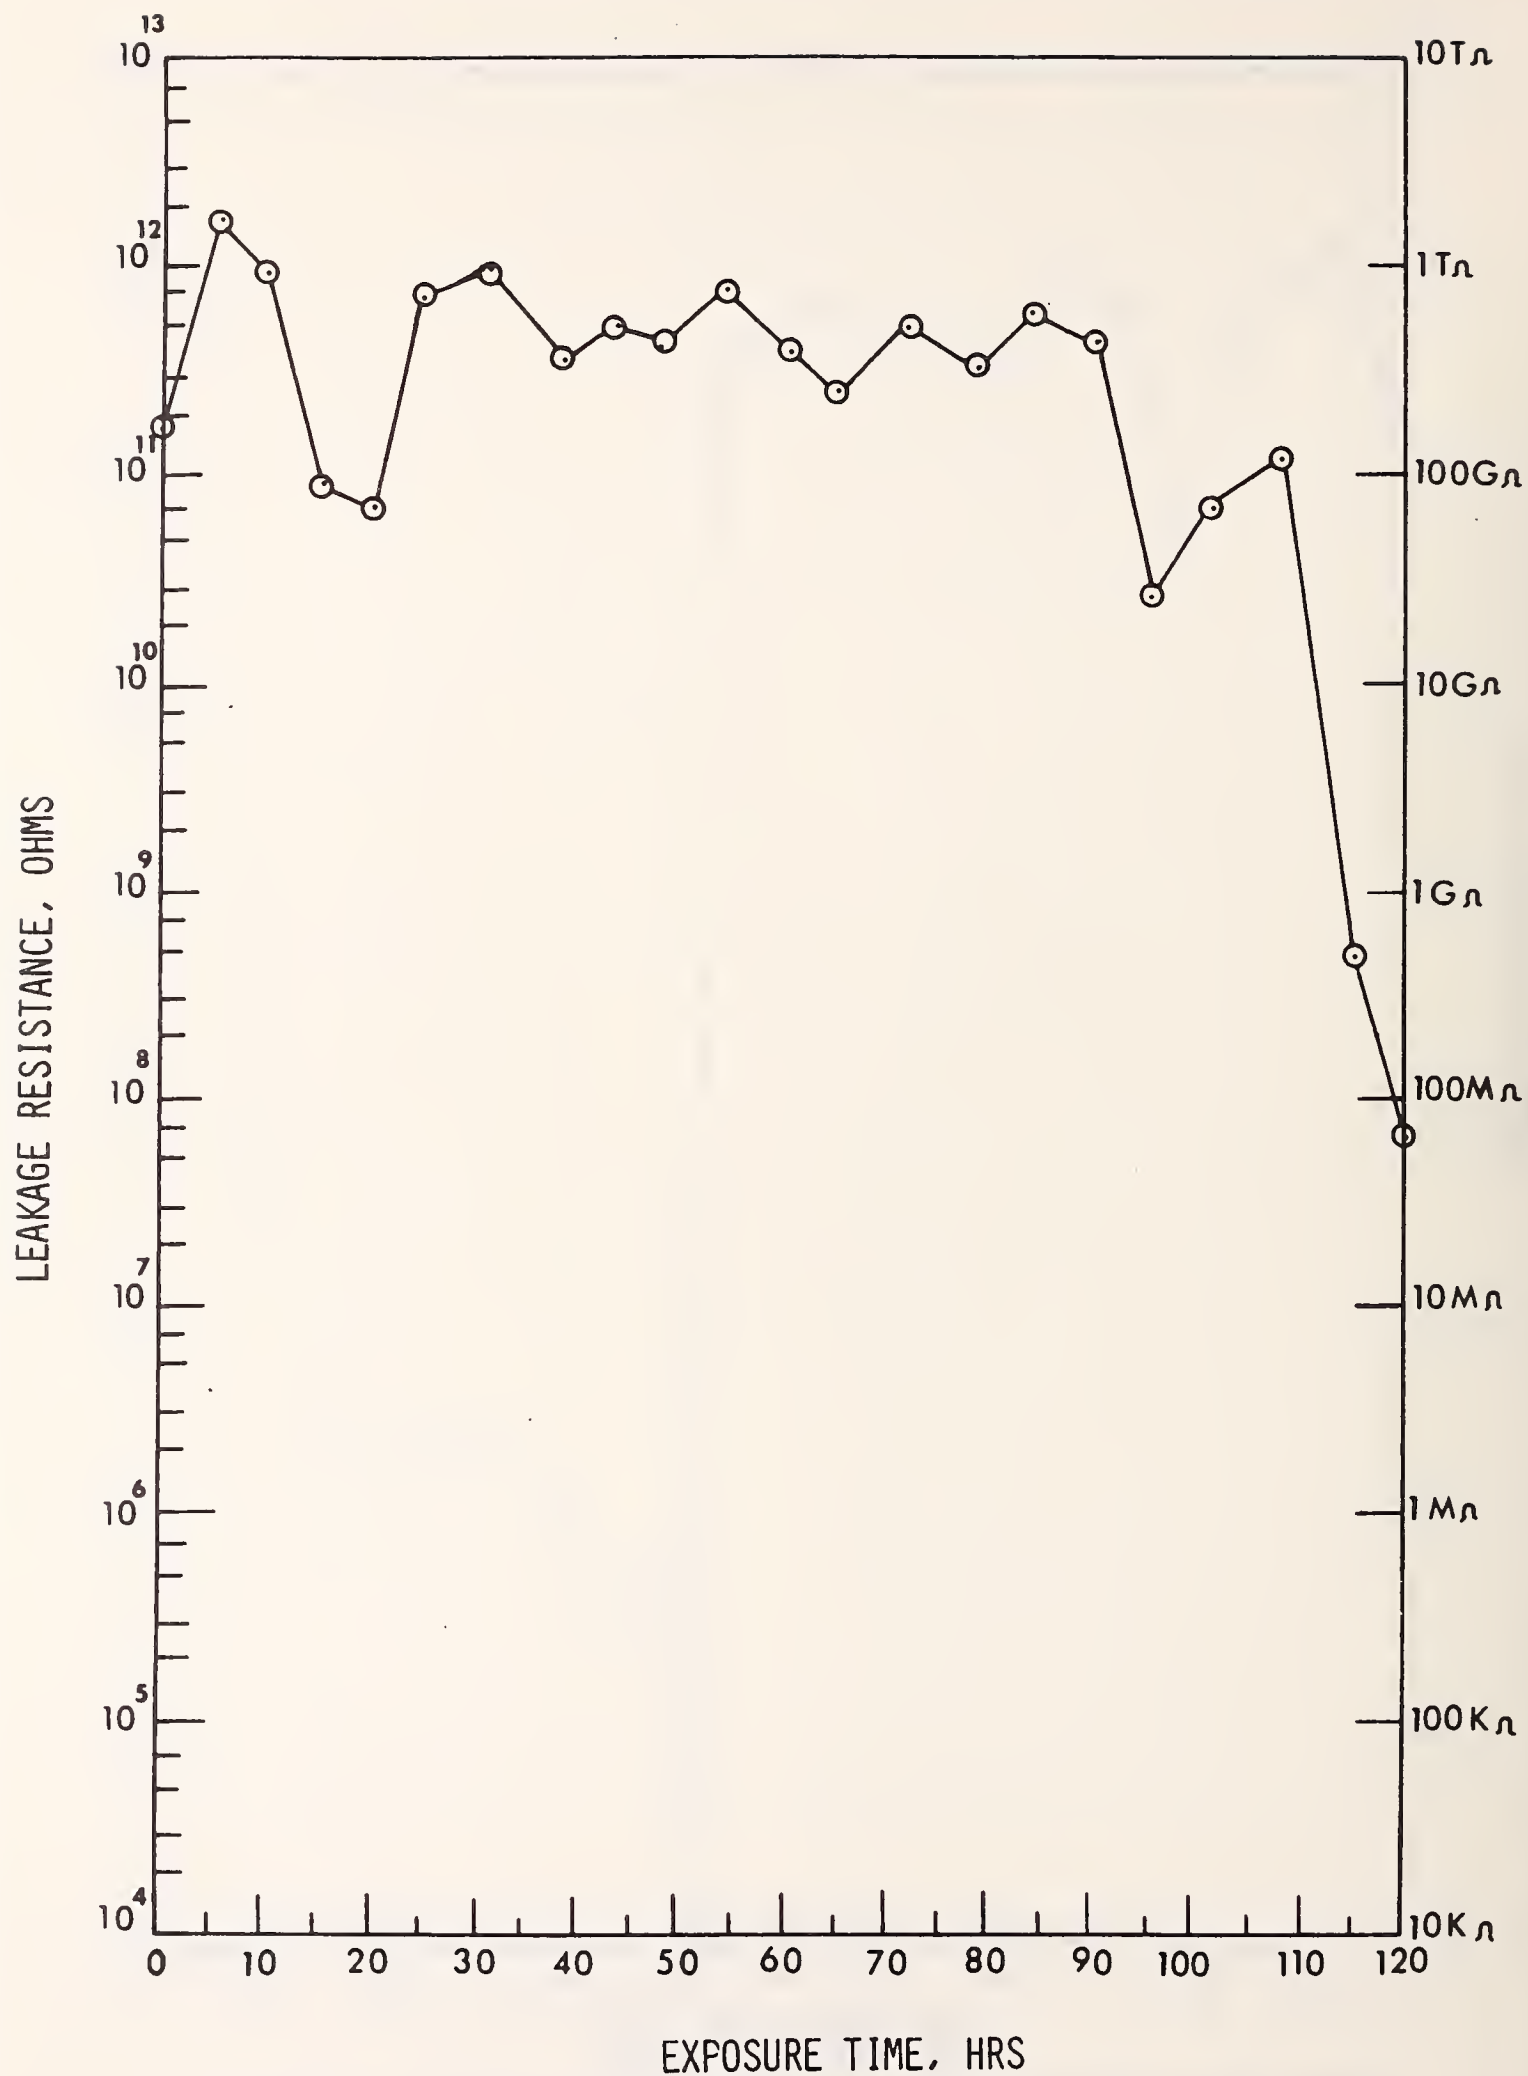
Figure 2a. Electrical leakage resistance for flat transducer No. 1B.

Figure 2b. Electrical leakage resistance for flat transducer No. 2B.

Figure 2c. Electrical leakage resistance for flat transducer No. 3B.

Figure 2d. Electrical leakage resistance for flat transducer No. 4B.

Figure 2e. Electrical leakage resistance for flat transducer No. 5B.

Figure 2f. Electrical leakage resistance for flat transducer No. 6B.

Table 1 gives the results of the measurements of the electrical leakage resistances on each of the seven flat and seven round transducers. Figures 2 (a)-(g) and 3 (a)-(g) show graphs of leakage resistance versus exposure time to hot saline solution. The seven round transducers

The initial leakage resistance for the flat transducers was approximately 200 G Ω . Cycle-to-cycle variations of an half-an-order-of-magnitude were common. In general, the resistances remained quite high, greater than about 10 G Ω , until moisture entered the transducer. The resistances then decreased to less than 100 k Ω . In three instances (transducer Nos. 3B, 4B and 7B) the resistances fell to less than 10 k Ω . Figures 2c, 2d, and 2g show this graphically. This suggests that significant amounts of moisture had penetrated the stainless steel jackets. Overall, five of the seven transducers "failed" when the leakage resistances became less than 20 M Ω .^{8 9} The remaining two transducers (Nos. 5B and 6B) gave indications of impending failure, i.e., decreasing resistance. However, the resistances did not decrease to less than 20 M Ω and therefore, they were not considered as failures. Table 2 gives the time to failure for each of the seven flat transducers tested. Examining Figures 2e and 2f, it can be seen that the resistances exhibited dramatic decreases near the end of the 120-h exposure time. It is probable that they were near failure. The mean time for the five transducers which failed is about 81 hours, as shown in Table 2. This value does not include transducer Nos. 5B and 6B. Had the latter two been tested to failure, the mean time would have increased to at least 92 hours.

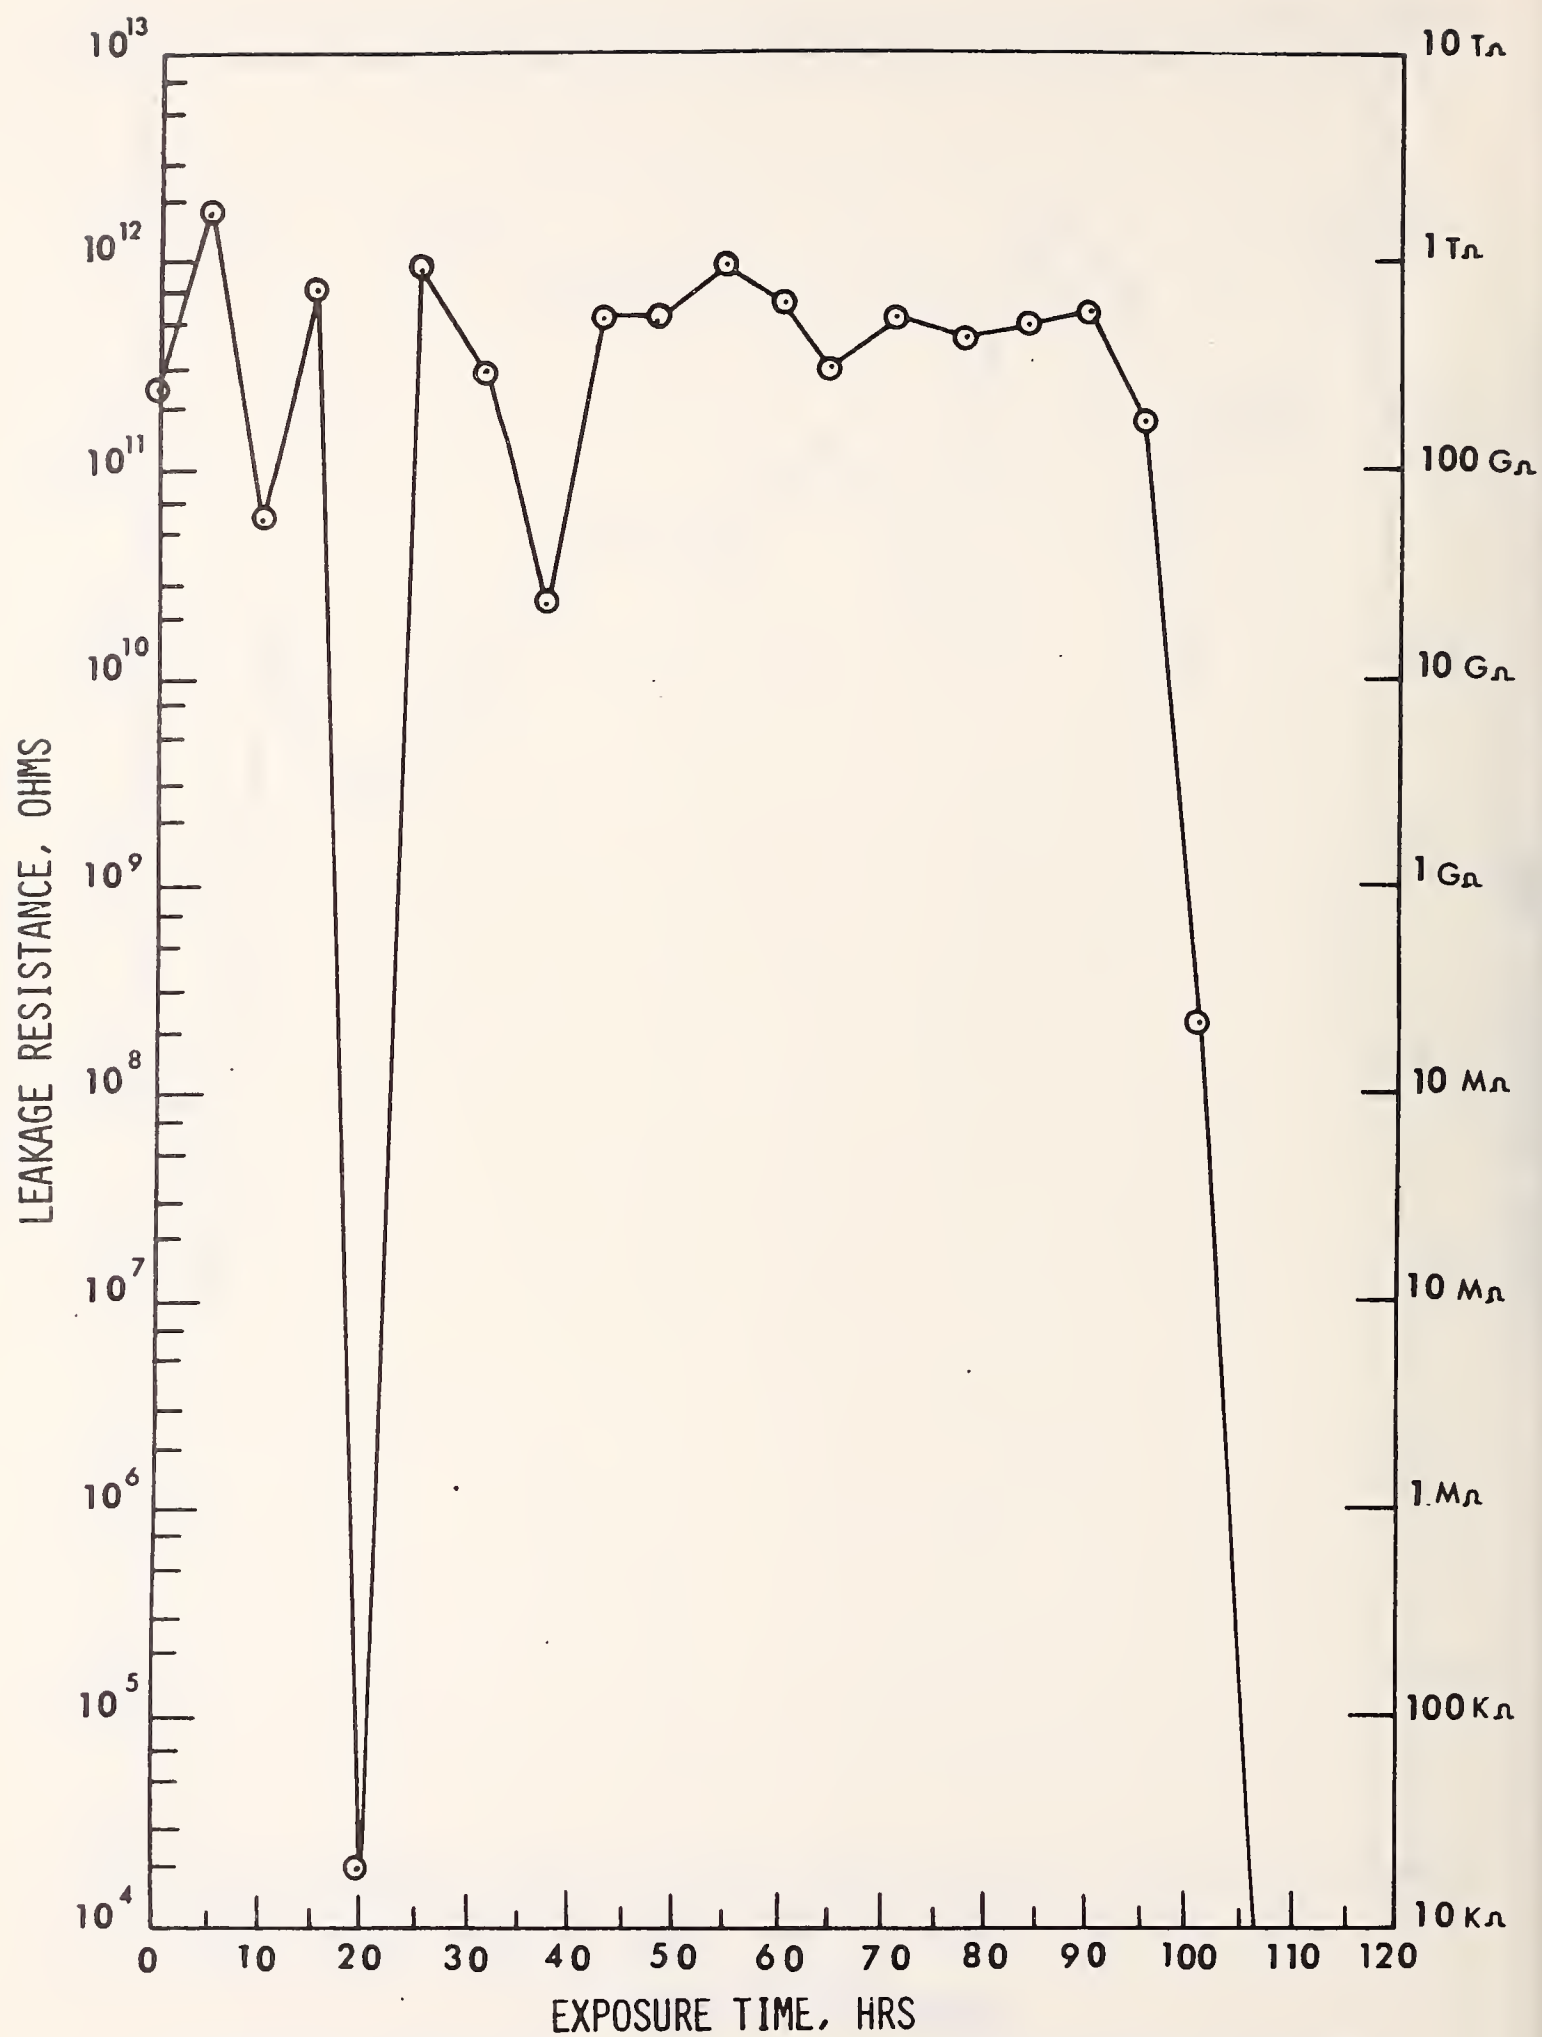
Figure 2g. Electrical leakage resistance for flat transducer No. 7B.

Transducer No. 7B (see Fig. 2g and Table 1) showed a dramatic decrease of leakage resistance after 20 hours of exposure; it then went back to a normally high value. This low resistance measurement (about 20 k Ω) was verified. The low value and the "healing" are unexplained. Perhaps some insulation material shifted or broke down, temporarily, due to the temperature cycling, and repaired itself. This transducer did not exhibit indication of moisture penetration until much later (after about 108 hours of exposure).
